16 yo high school running back with worsening right wrist pain one year after scaphoid nonunion surgery at another hospital. Xrays demonstrate a loosened screw, persistent nonunion and instability affecting the neighboring lunate bone.

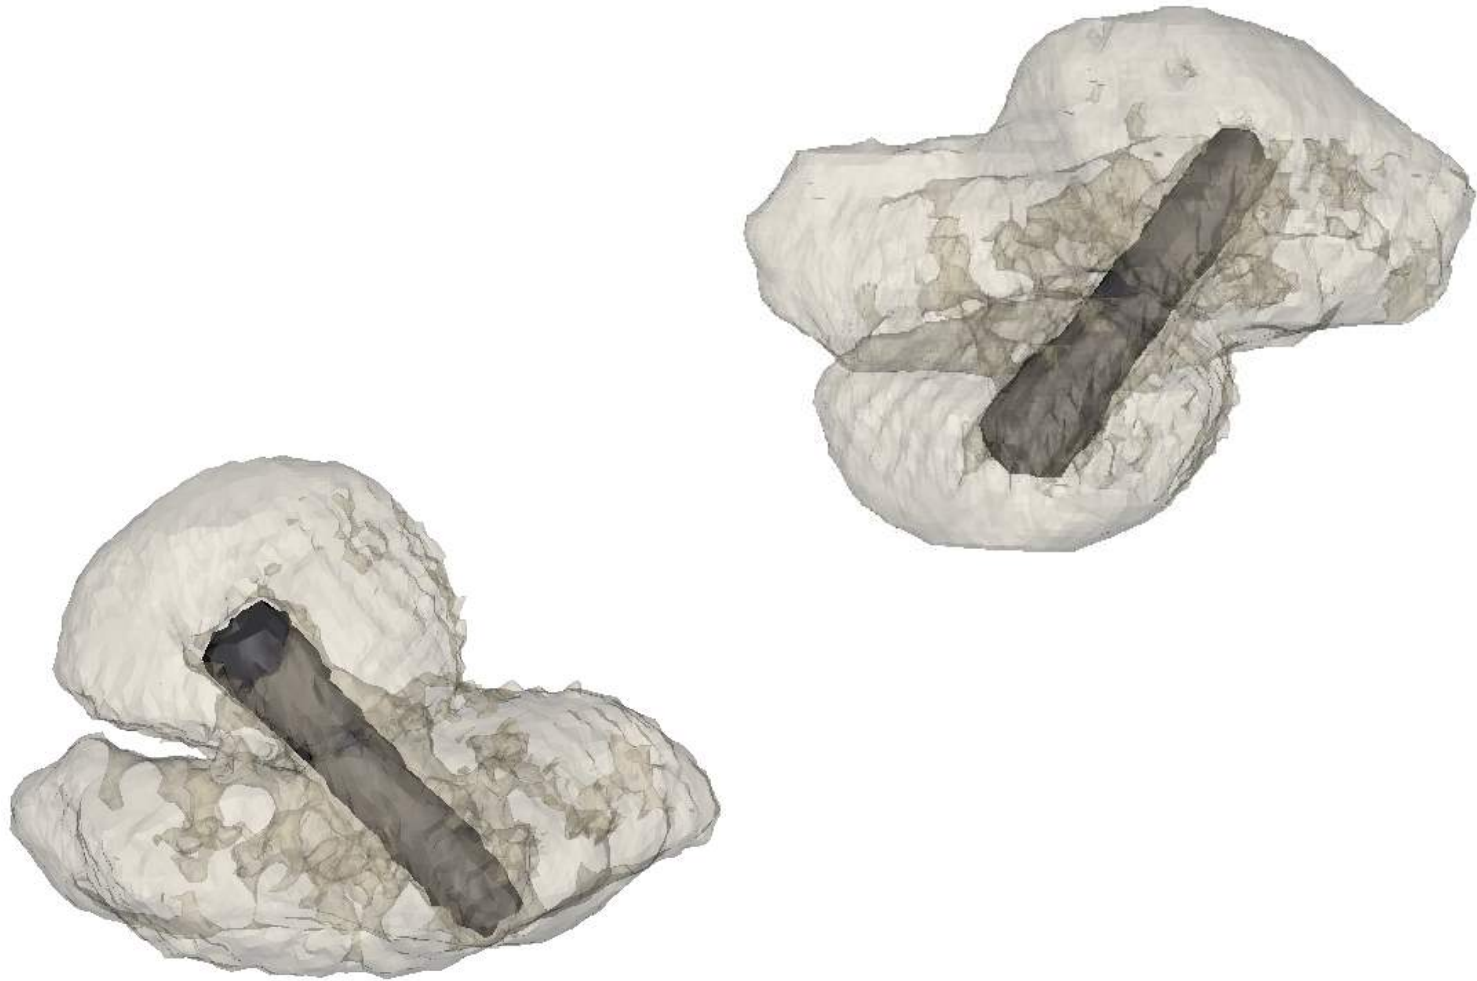
B.

Three dimensional reformat of high resolution computed tomographic scans to enable virtual surgical reconstruction.

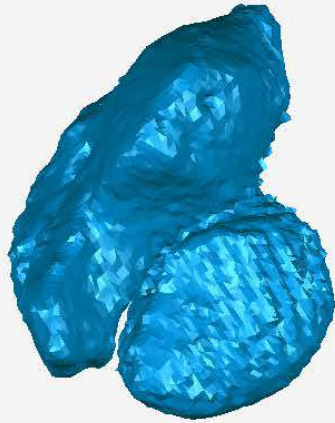
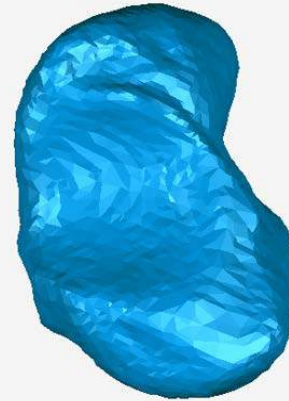
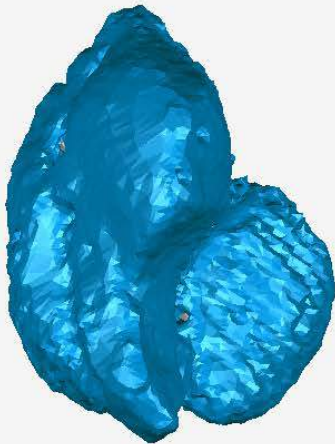
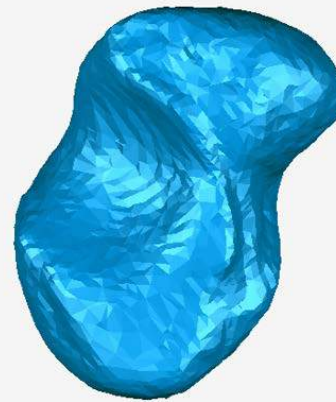
C. Right scaphoid

Injured 3D scaphoid compared to normal left scaphoid.

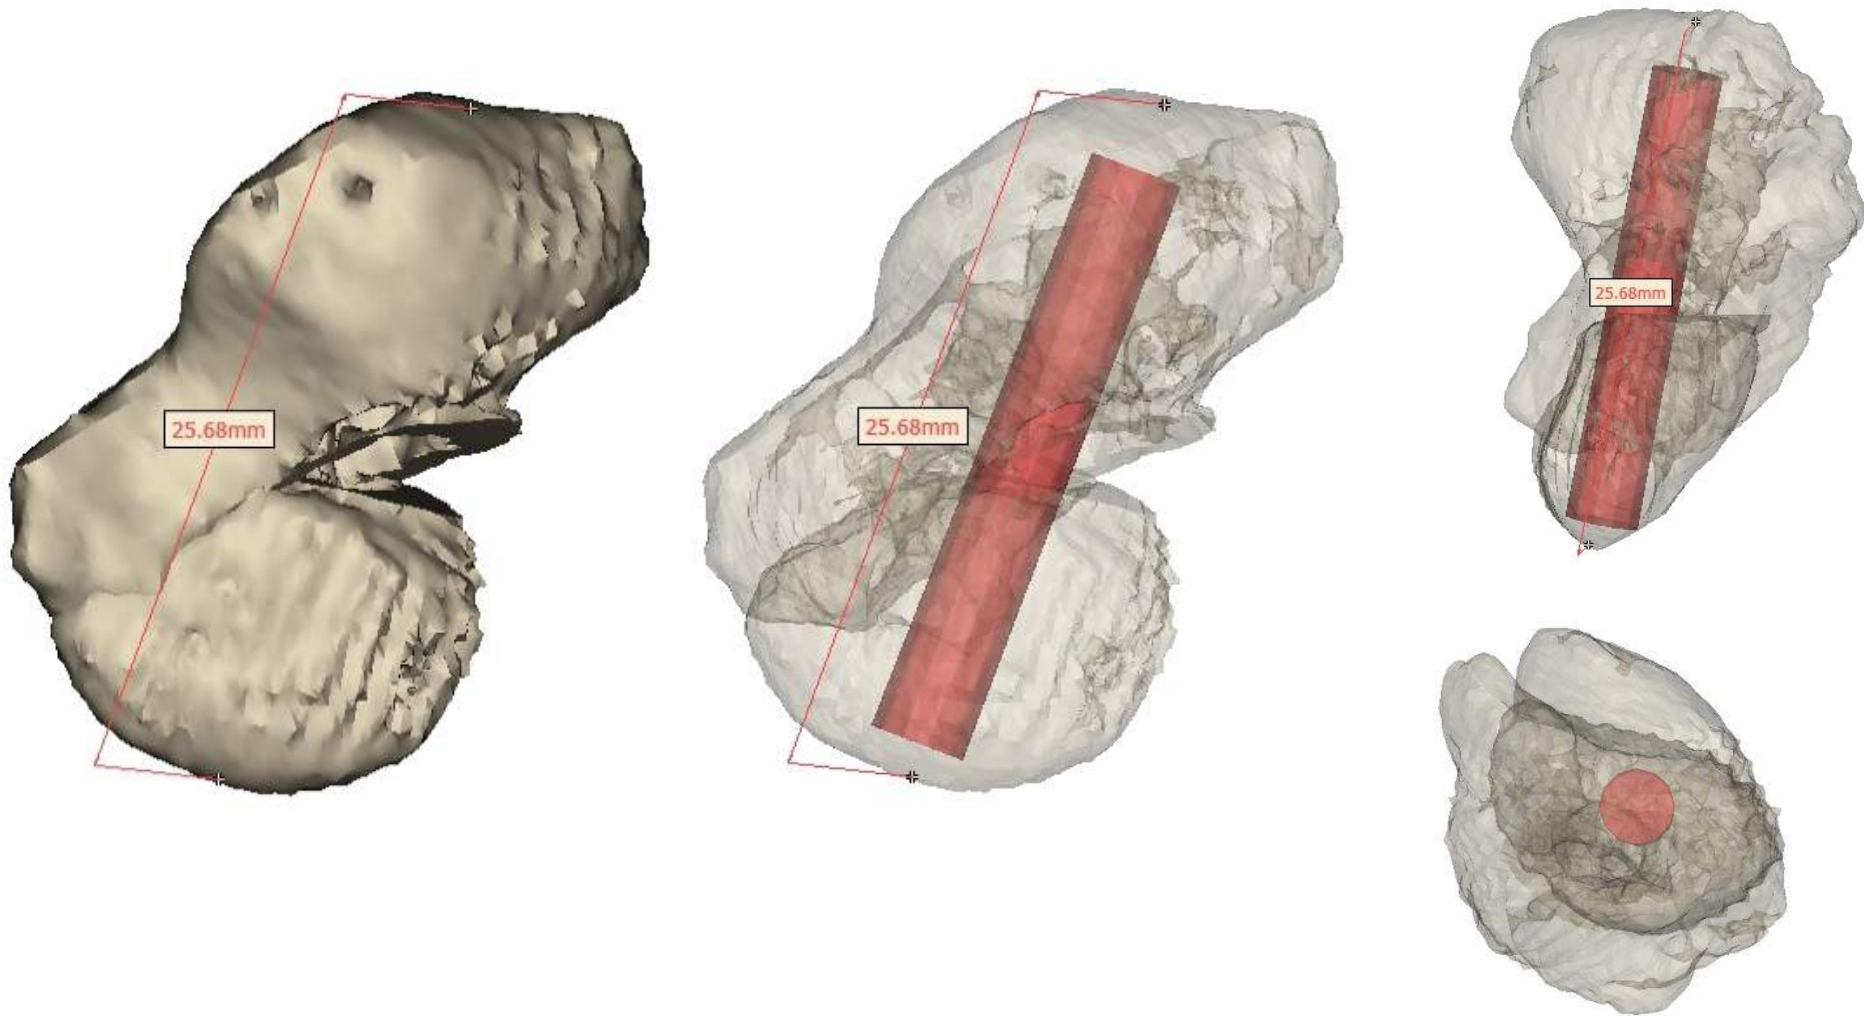
D.

Virtual surgical repositioning of fracture fragments, demonstrating need for bone graft to fill wedge defect in central scaphoid, and sized for appropriate screw length and position.

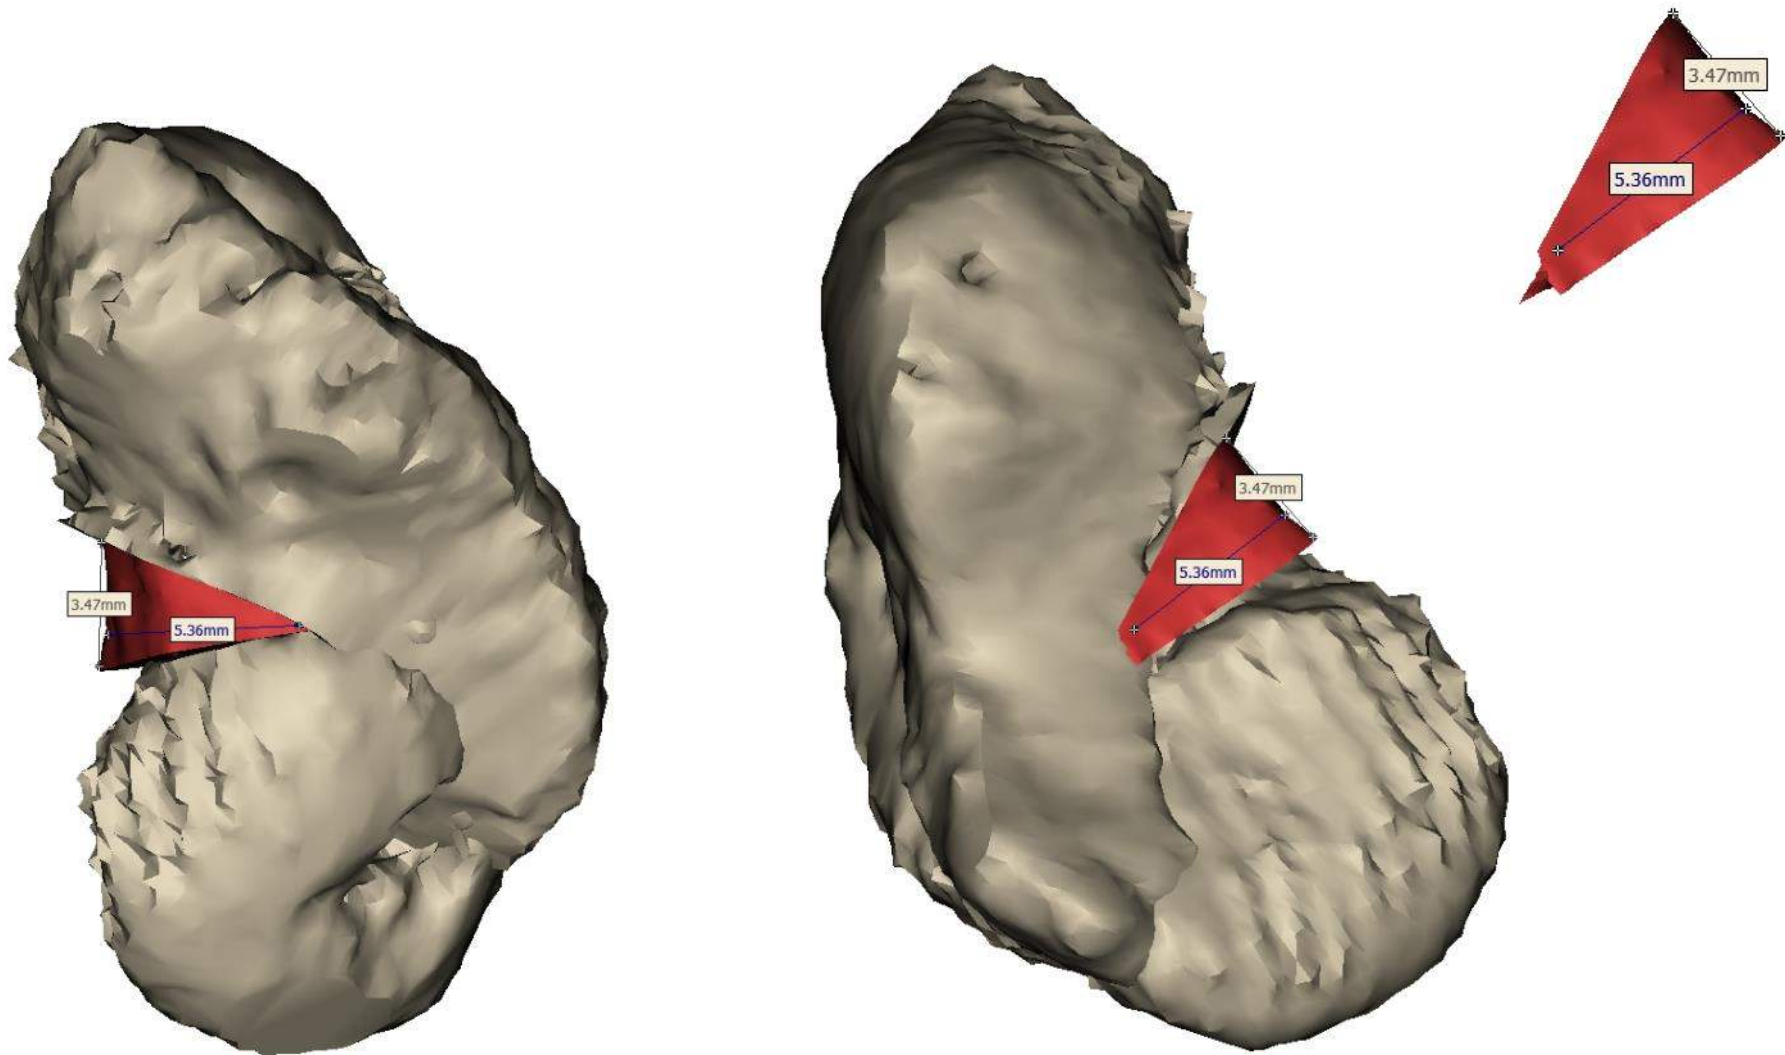
E.

Exact size and dimensions of bone graft calculated.

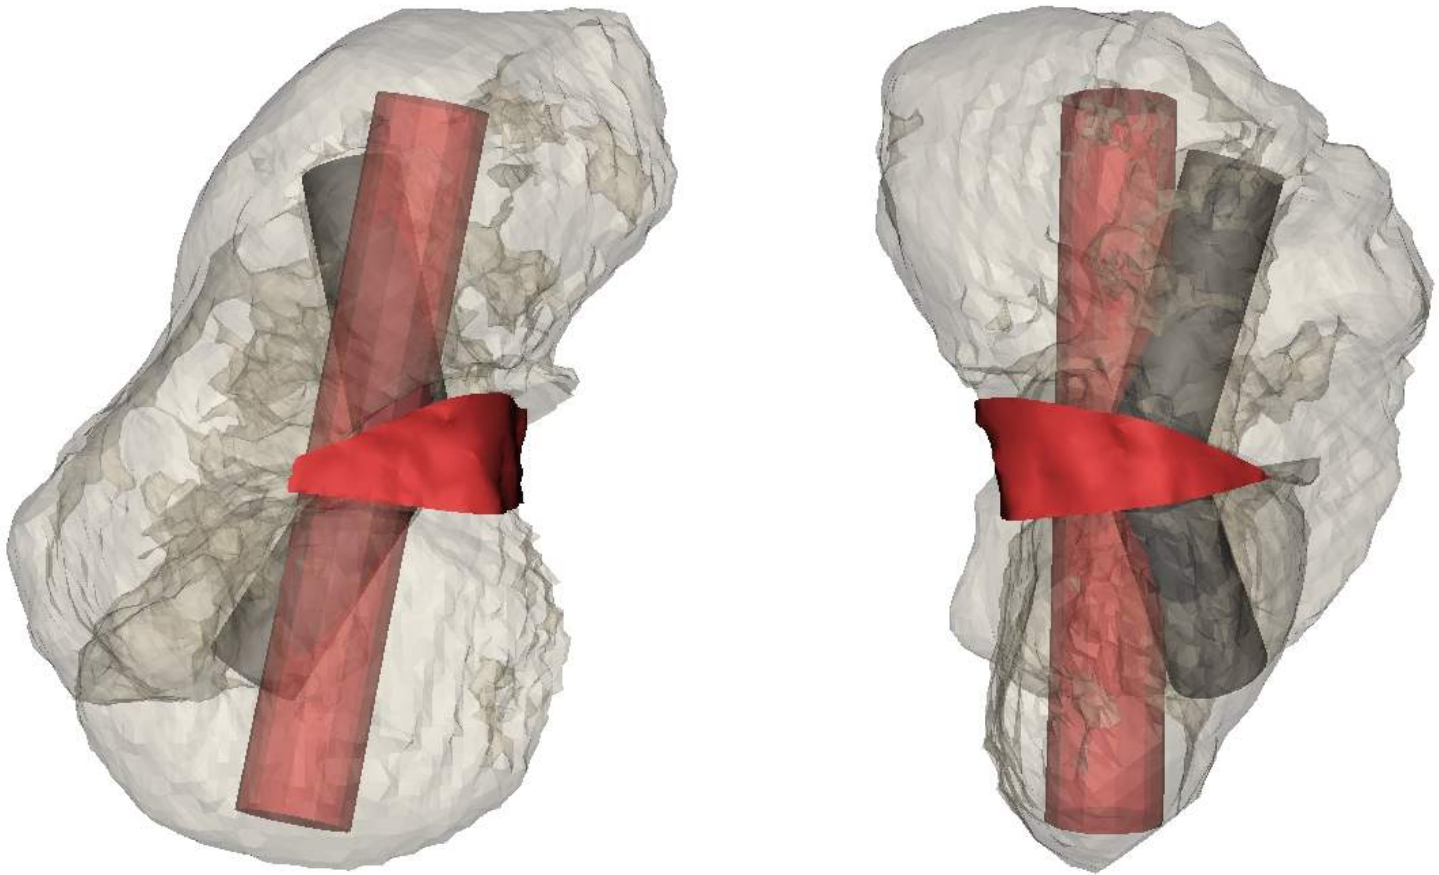
F.

Overlay of virtual reconstructed scaphoid on current scaphoid nonunion.

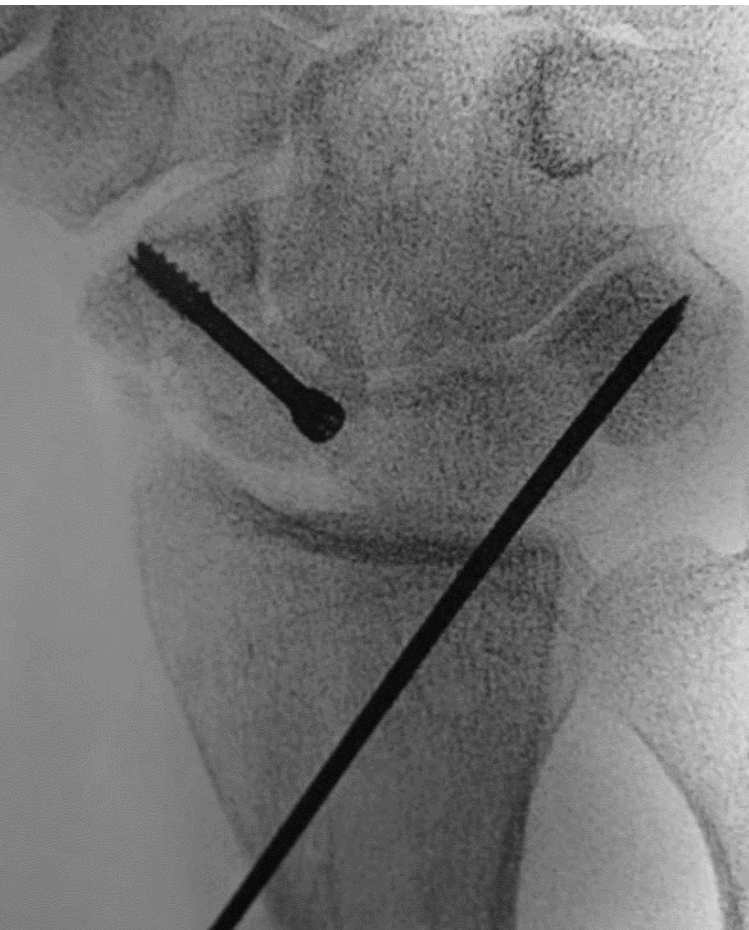
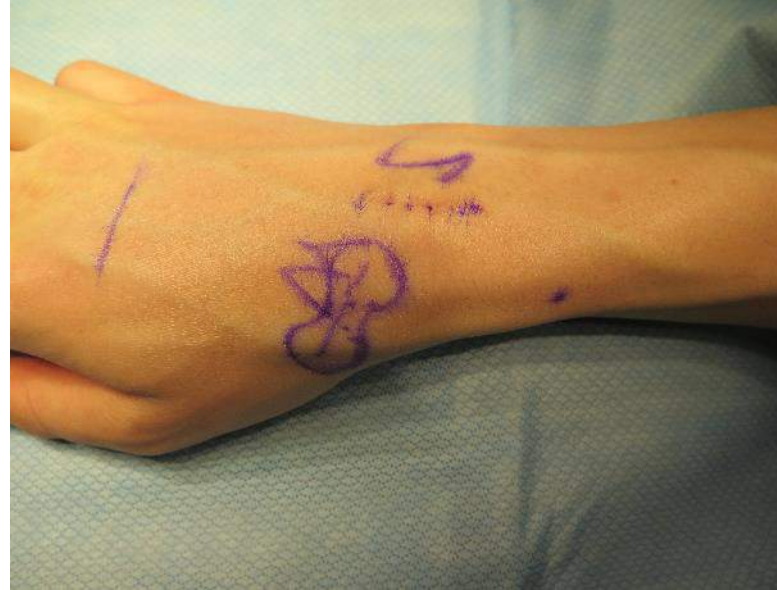
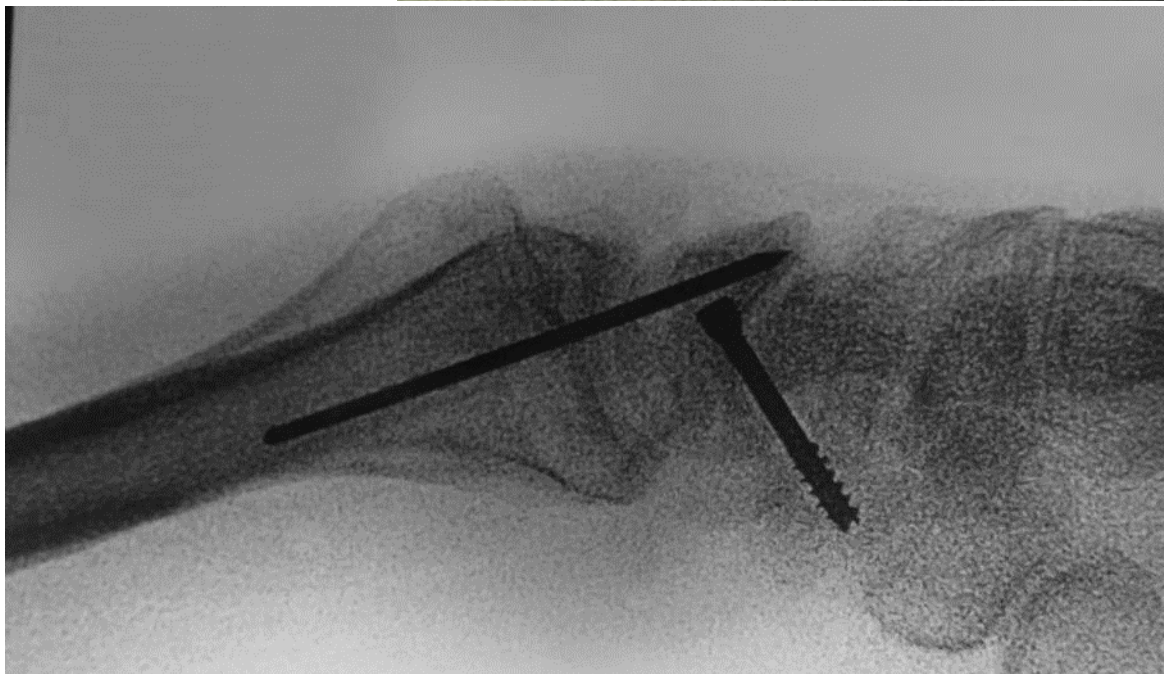
G.

Surgical markings and operative fluoroscopy views of completed reconstruction and internal fixation of scaphoid and lunate.

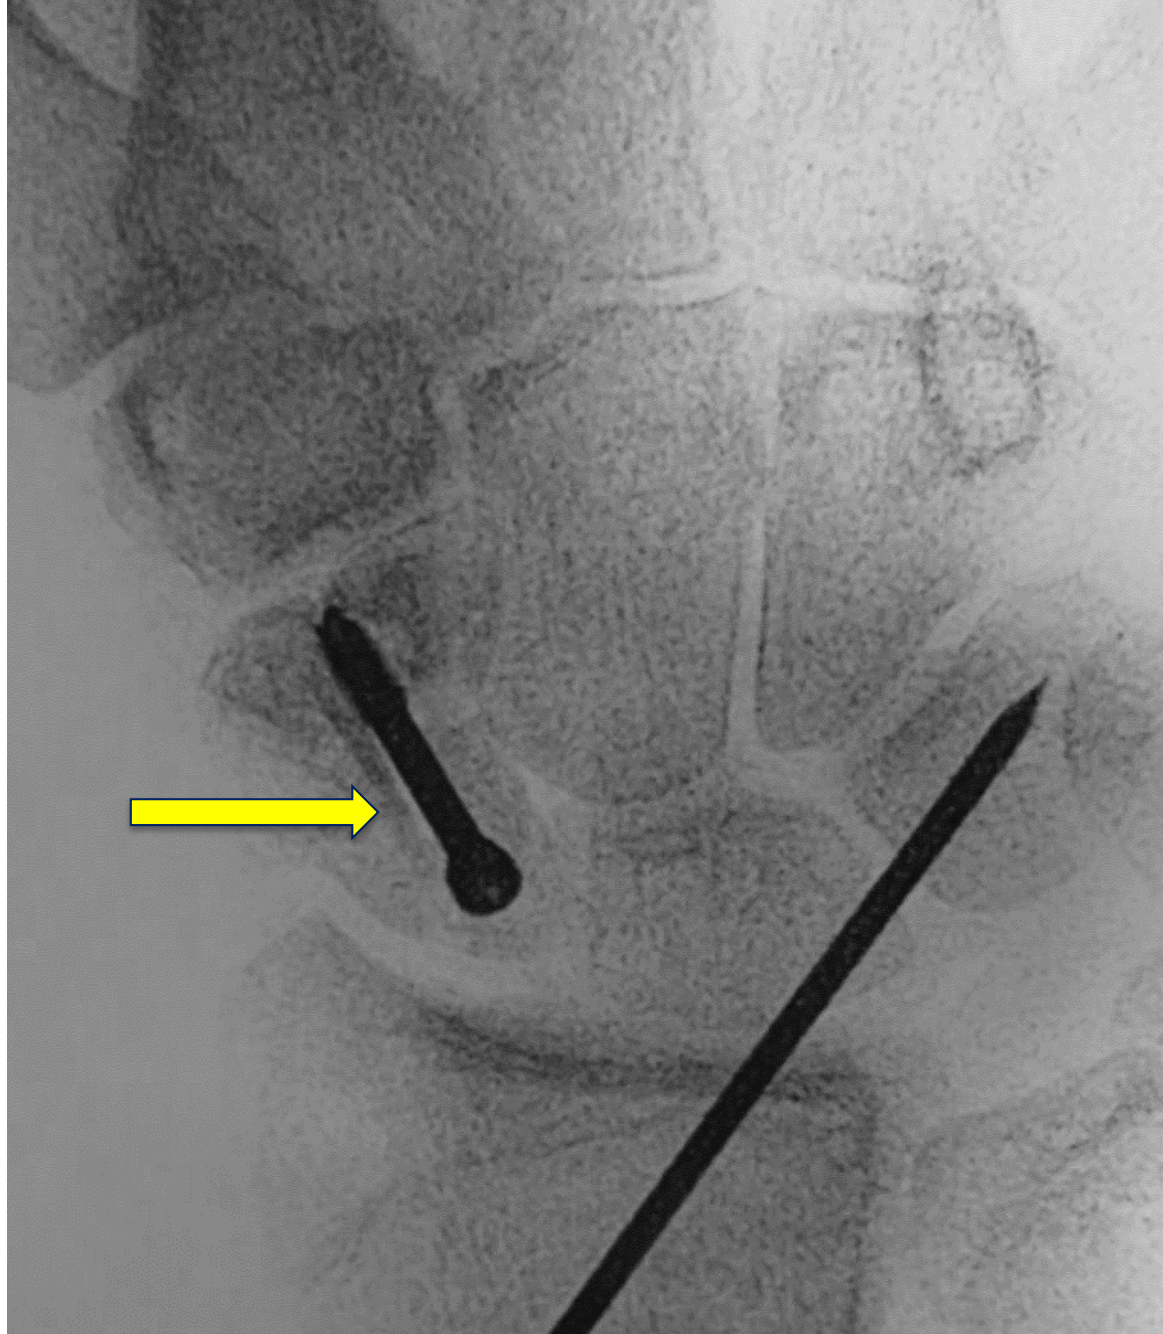
H.

Yellow arrow identifies strut of bone graft bridging nonunion site.

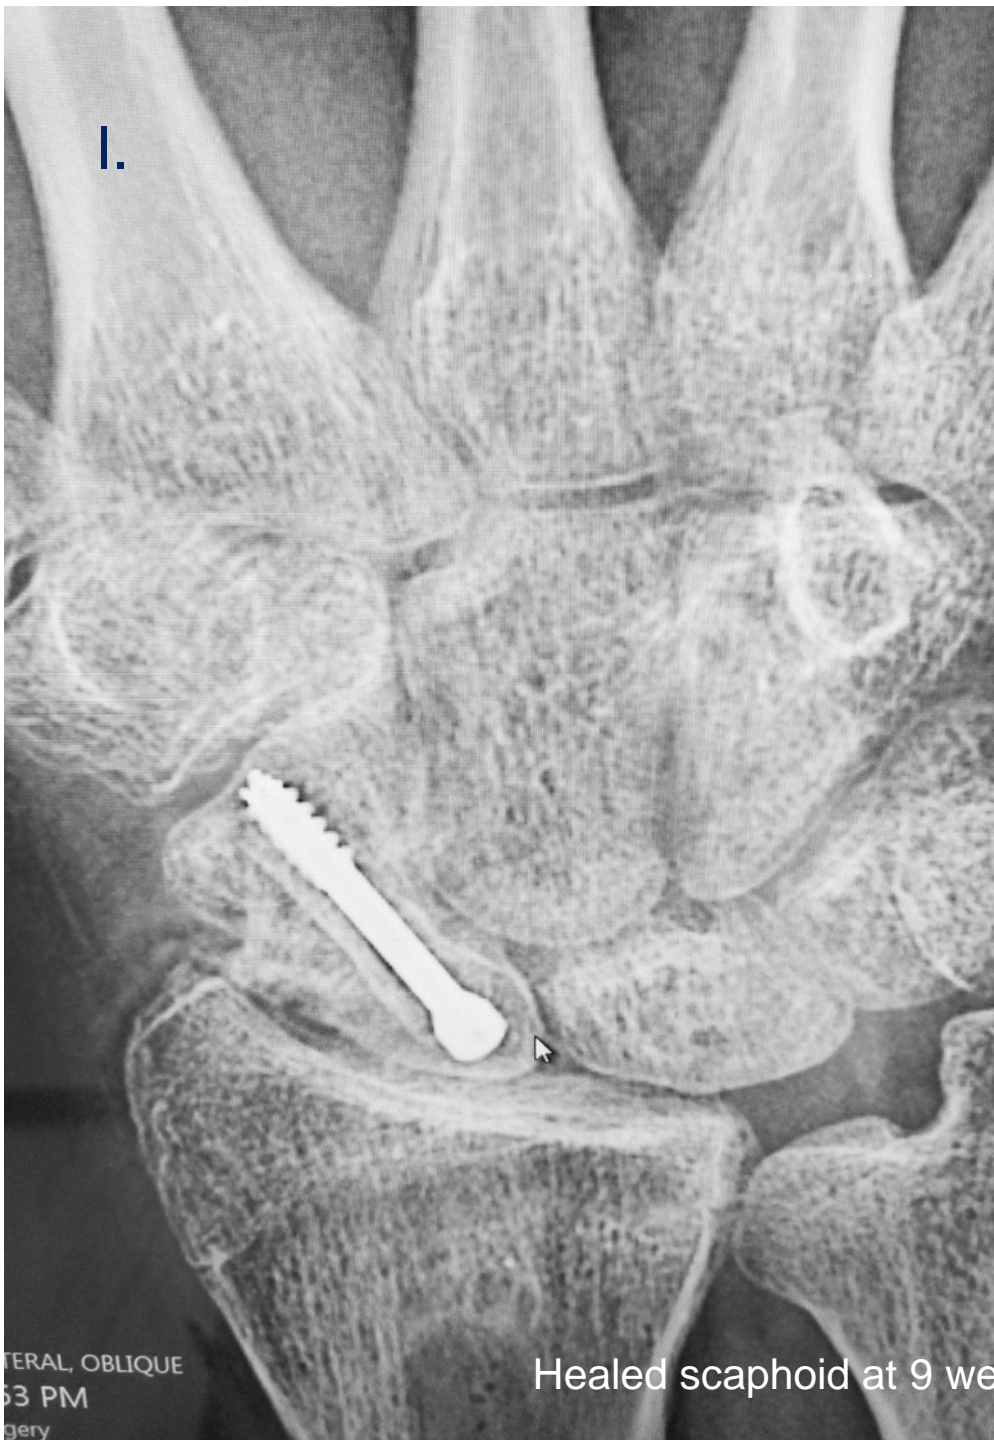
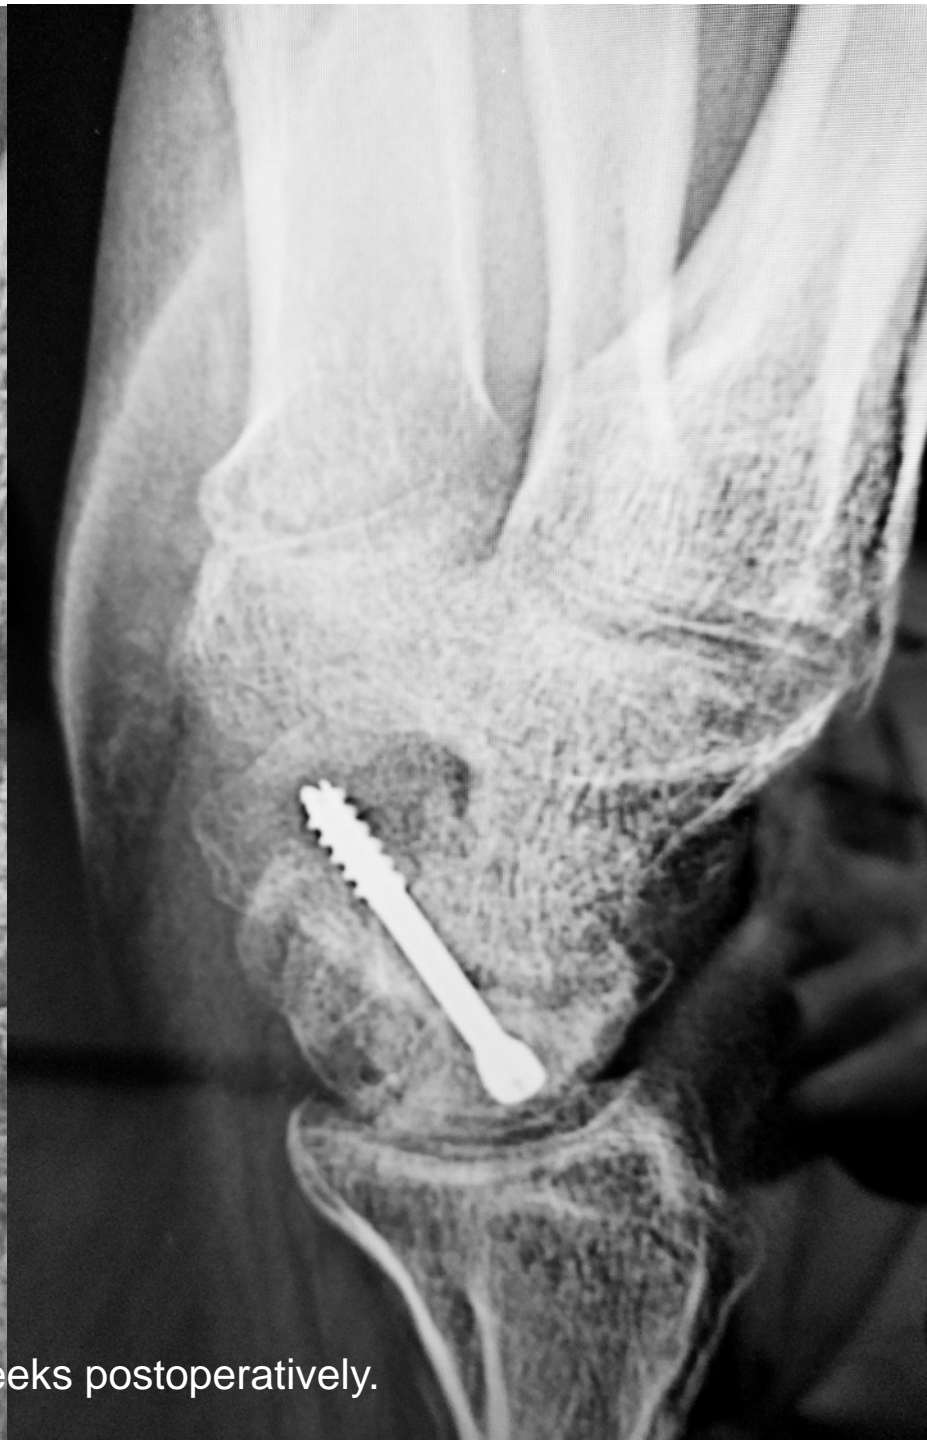
Healed scaphoid at 9 weeks postoperatively.

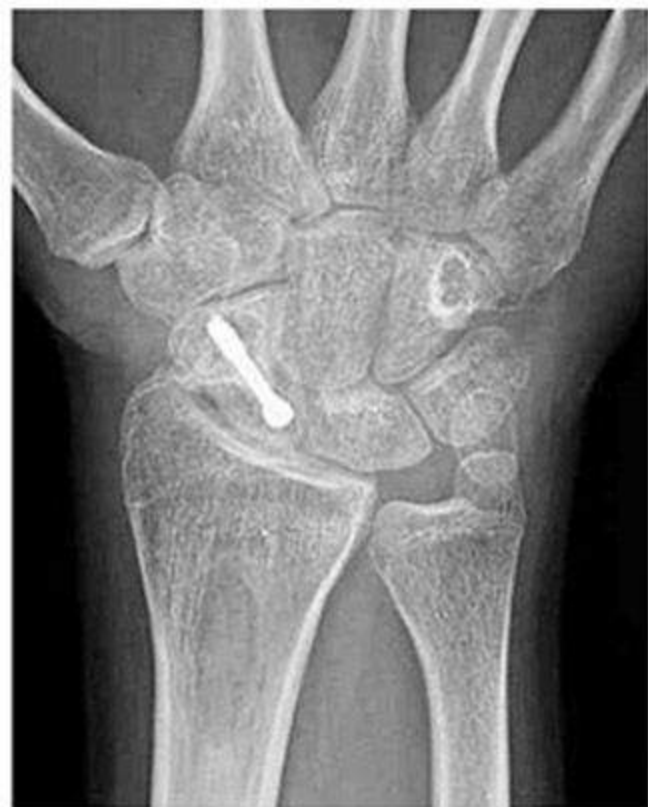
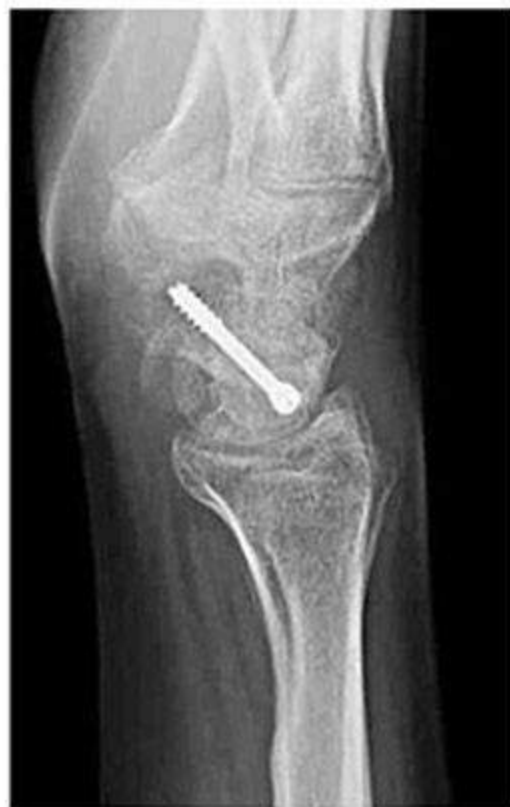
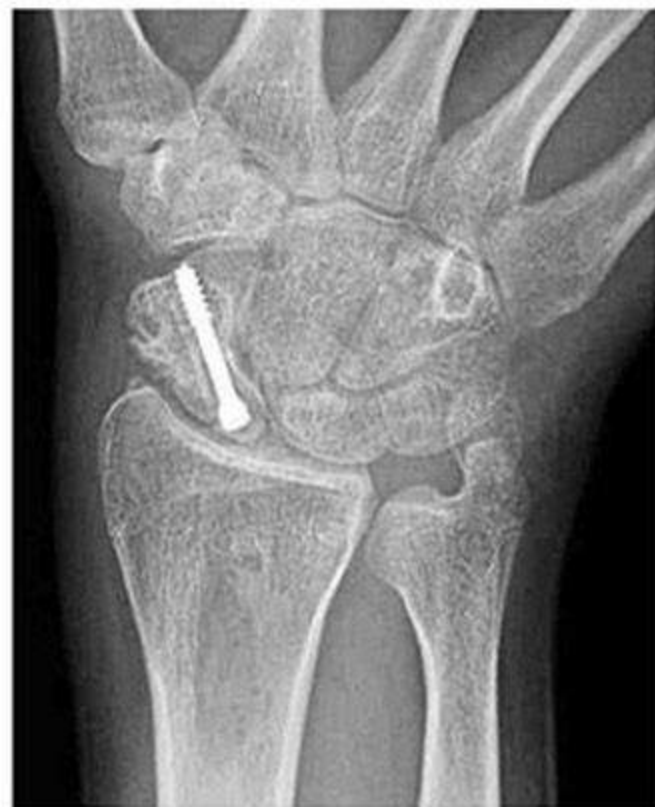
AC: s/p right scaphoid ORIF for non-union on 2/26/19
Radiographs from 6/7/19

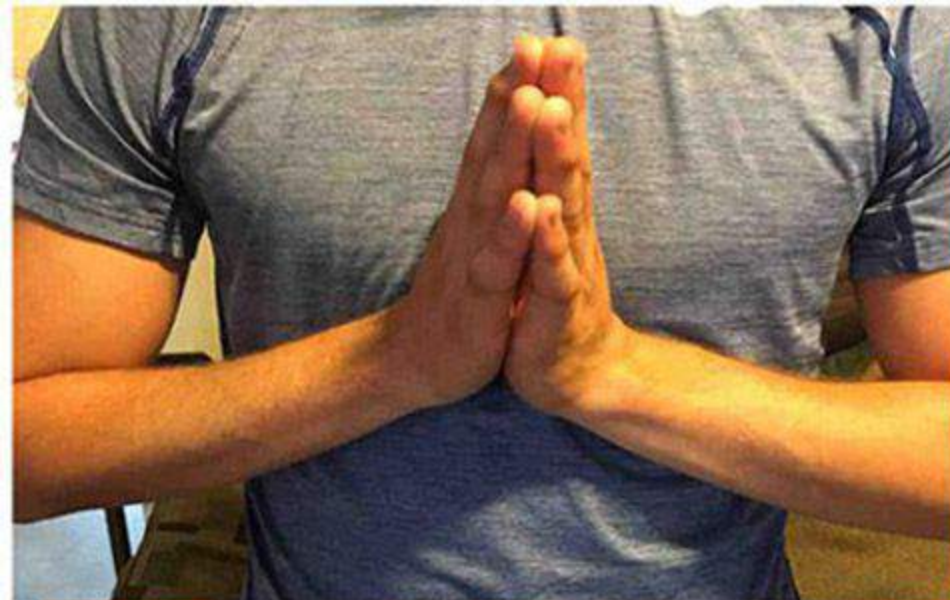
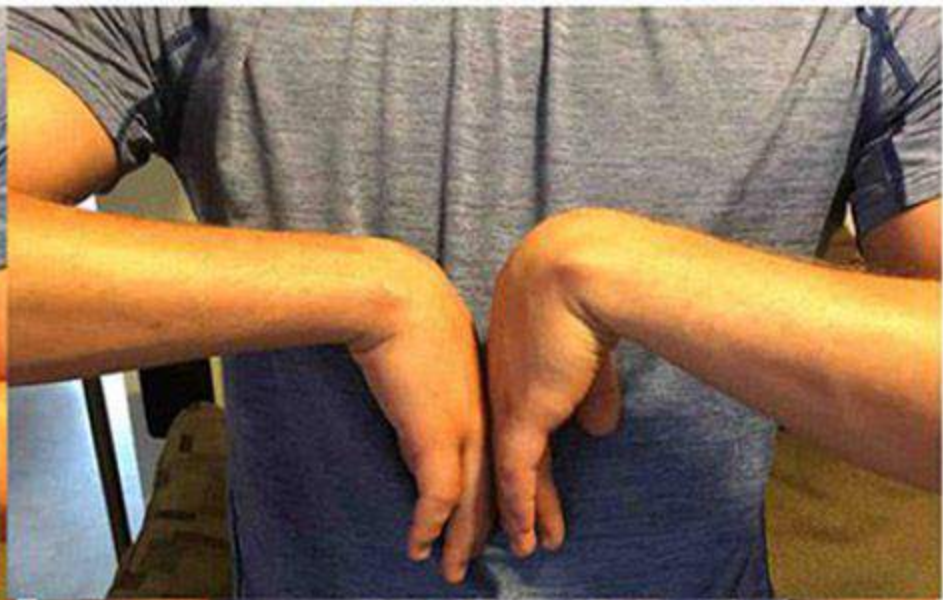
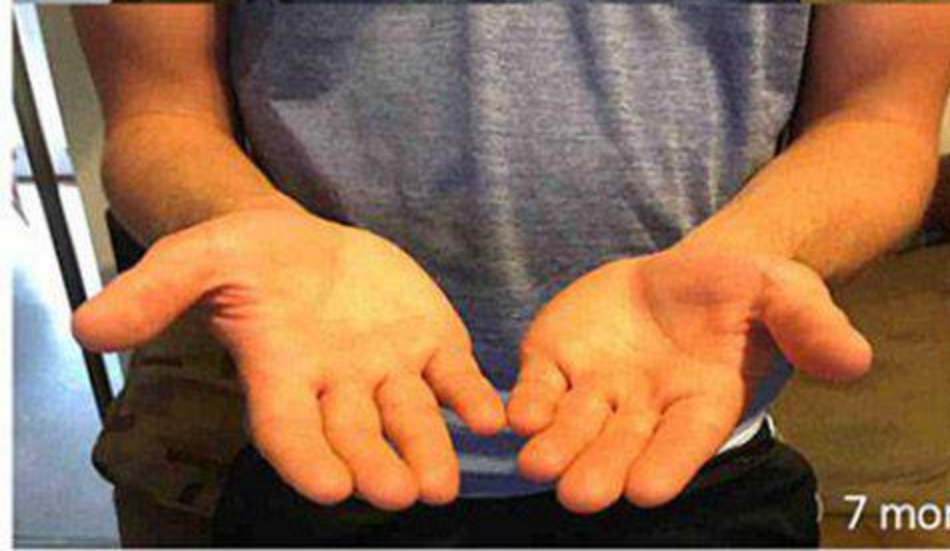
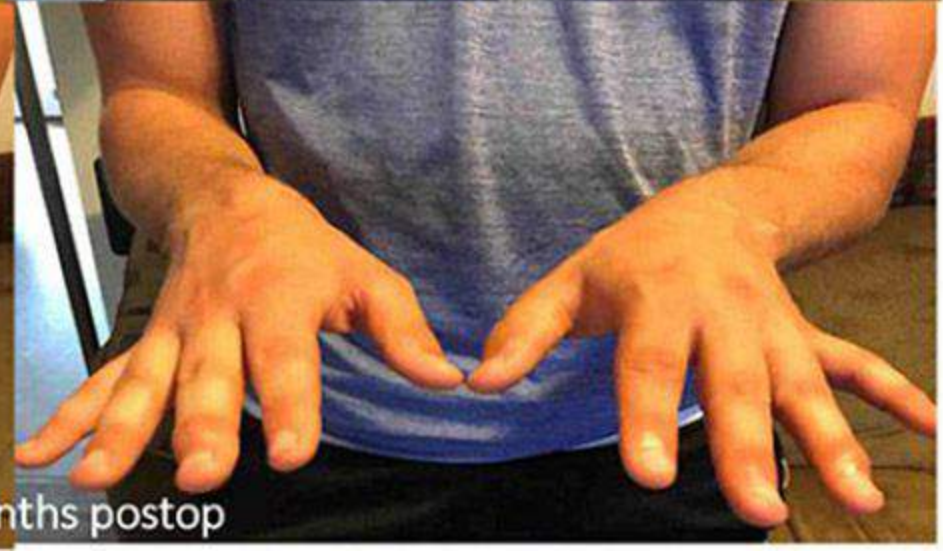
7 months postop
